U.S. DEPARTMENT OF
ENERGY

WIPP Underground Fire Accident Investigation Summary February 5, 2014

Ted Wyka
Chairman, Accident Investigation Board
March 2014

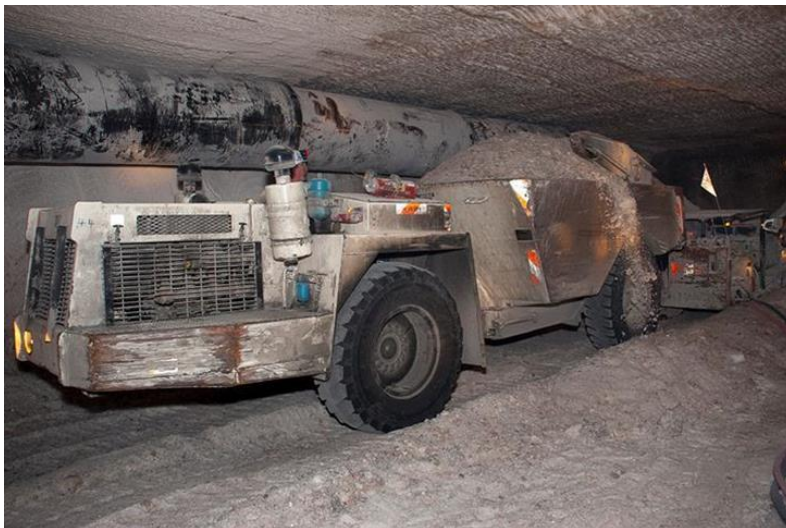
The EIMCO Model 985, 15 ton haul truck is a diesel powered vehicle used to haul salt from the mine. This is an aged piece of equipment, approximately 29 years old.

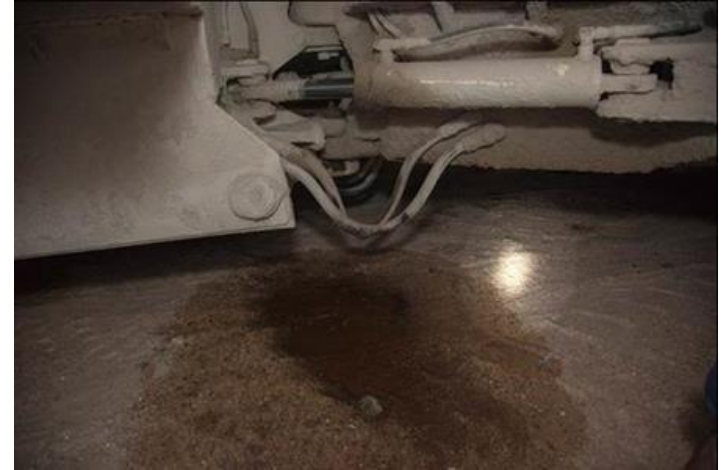
Hydraulic Leak under Sister Vehicle

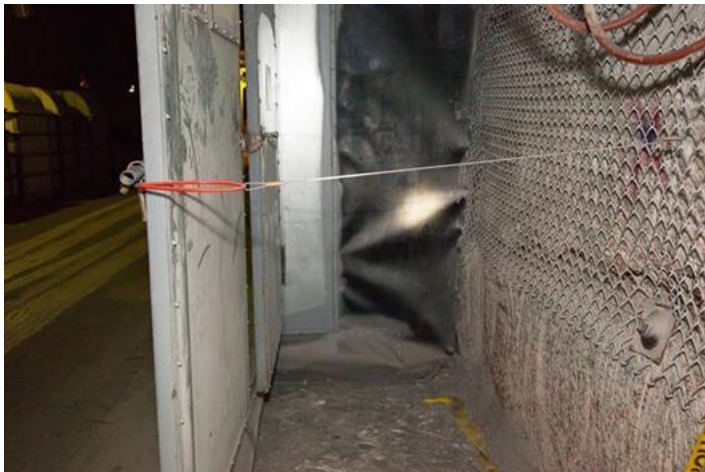
Air Lock Doors Wired Open

- **Operability and recognition of impaired critical safety equipment,** e.g., salt haul truck combustible build up; discontinued use of the vehicle wash station; chaining open of ventilation doors impairing remote operation; inoperable ventilation fans; out-of-service regulator/damper; inoperable mine phones ; emergency lights in the Waste Handling Facility; obscured evacuation reflectors; decision and analysis to disable the automatic fire detection and suppression system, etc. No method to readily understand status and impact of impaired mine safety related equipment.

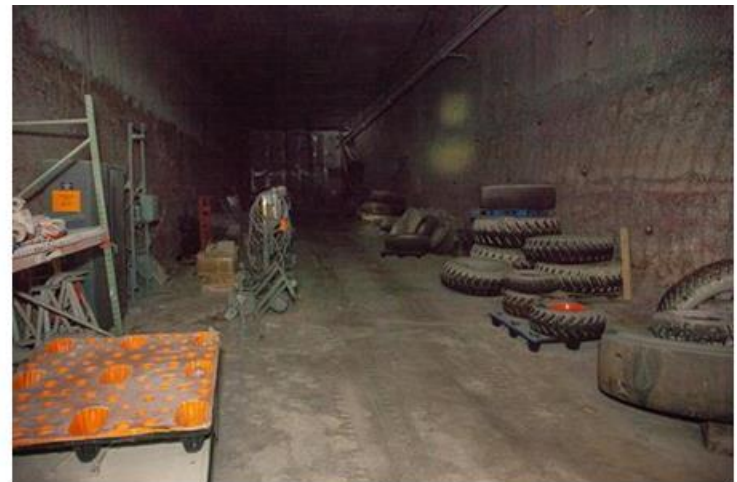
Combustible Loading in the Mine

- **Inadequate combustible loading program in the underground.**
- **Inadequate Fire hazard Analysis** (i.e. analysis of a fire near a shaft)
- **Maintenance, Emergency Management/Preparedness programs and NWP contractor assurance system (CAS) and CBFO oversight** were evaluated as **ineffective.**

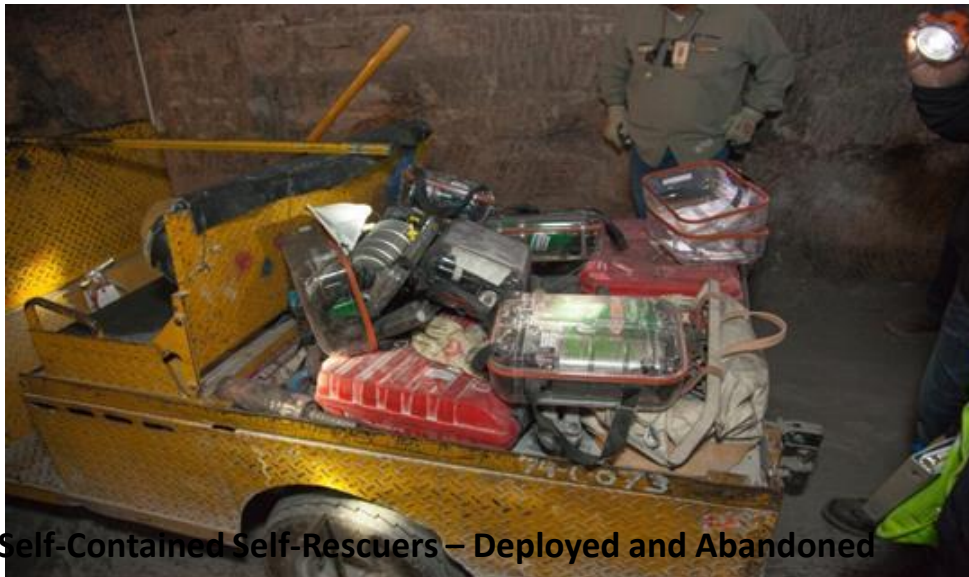
Self-Contained Self-Rescuers – Deployed and Abandoned

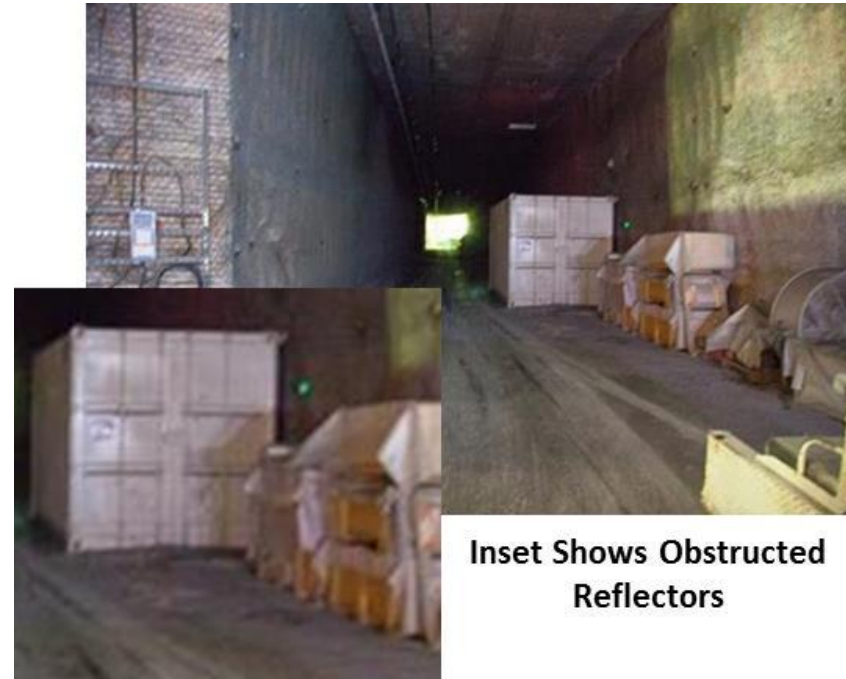
Inset Shows Obstructed Reflectors
