U.S. DEPARTMENT OF
ENERGY

WIPP Underground Fire Accident Investigation Summary February 5, 2014

Ted Wyka
Chairman, Accident Investigation Board
March 2014

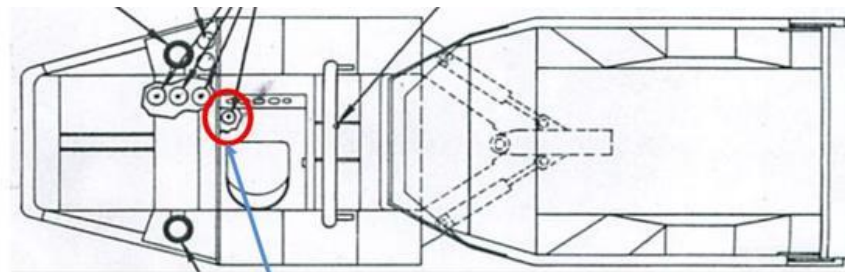
(a) Plan View

- The Board has been unable to perform detailed physical forensics on the vehicle underground due to the February 14th radiological event.
- The Board reviewed photographs taken with forensic experts including a New Mexico Fire Investigator from the State Fire Investigation Bureau and the Eddy County New Mexico Fire Marshall.
